May 31, 2024

RE: Pre-Development Impact Assessment & Tree Protection Plan

Location - 967 Isabell Avenue - Langford B.C.

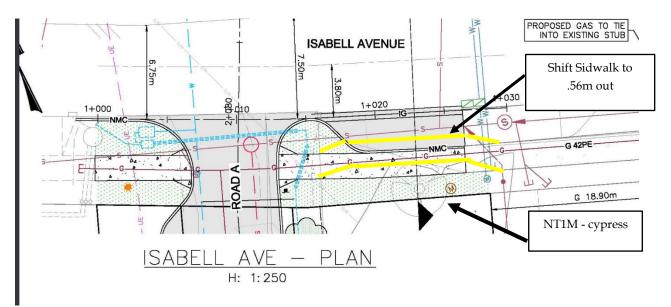
Figure #1 - Proposed Civil Drawing & Tree NT1M Cypress

Tree NT1M cypress a border line property tree positioned along Isabell Avenue was previous assessed and recommend for removal – In this case we have reassessed the viability of the trees retention and have proposed that the tree be preserved through mitigation techniques. Our experience, when compared to the trees profile give this tree a 50% chance of survival when the CRZ is expanded reducing further root impacts – Please see the previous comments below.

Upon assessing the tree and reviewing the site plan it is evident that the cypress tree should be removed under the existing proposal for the site. Lot "A" where the tree is located will require improvements along the frontage (sidewalk) and road dedication. Combined a new driveway alignment and dwelling setbacks will be positioned within 2m of the cypress tree. Our observations indicate that every side of the trees CRZ will be impacted under the existing proposal.

Our observations have indicated that the amount of root and soil disturbances proposed for the site will far exceed Tree Care Industry Standards. Assessed to have more than 40% of the PRZ removed and/or disturbed during development we believe that the tree would have an increased risk in the landscape. This species of cypress cannot withstand structural root loss. Due to its weighted, evergreen canopy Leyland cypress have higher than normal failure potential when isolated as individual specimens in the landscape. – June 2022 – Arborist report SSFC

- Project Arborist to provide Post Excavation and Impact Assessment Memo to City of Langford Staff within a reasonable timeline.
- Provide tree protection fencing and mitigation techniques for Tree NT1M cypress. The proposed improvements for this area of the site will be completed at the end of the project to ensure that the trees CRZ is fully protected. Coordination of development in this area of the site must be scheduled with the Project Arborist. Alternative paving, sidewalk design and excavation techniques will be required for tree NT1M cypress.

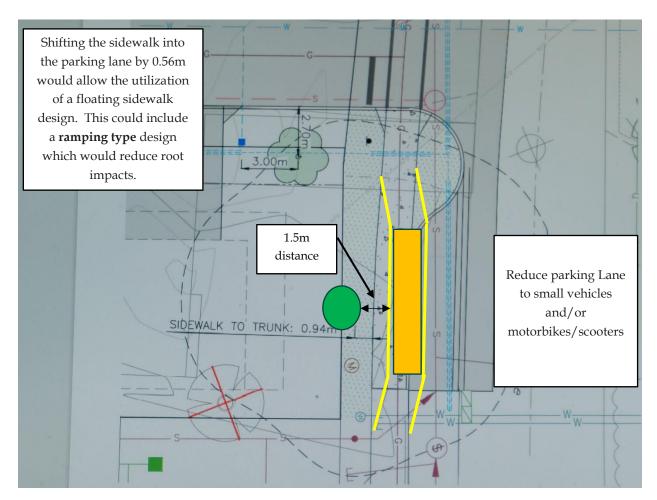
Figure #2 - Sidewalk Shift - Reduce Parking Lane

The proposed increase of 0.56m and the redesign of the sidewalk around the trees base would certainly reduce root impacts in the trees CRZ. The orange area indicates where the sidewalk can be floated over the tree's root profile reducing the excavation depth.

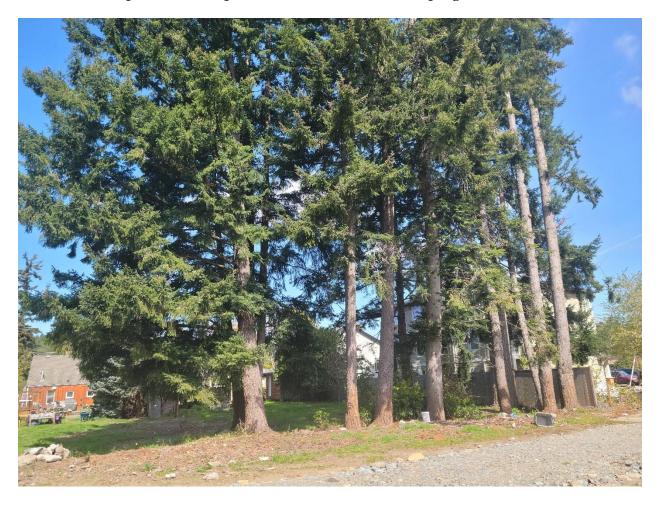
Photo #2 - Proposed GreenSpace Area A & Fir Tree Grouping

In this photo you can see the primary treed area of the site. This are of the site is proposed to be a Greenspace – Area "A" and therefore we are proposing to protect and retain several of the trees in this photo.

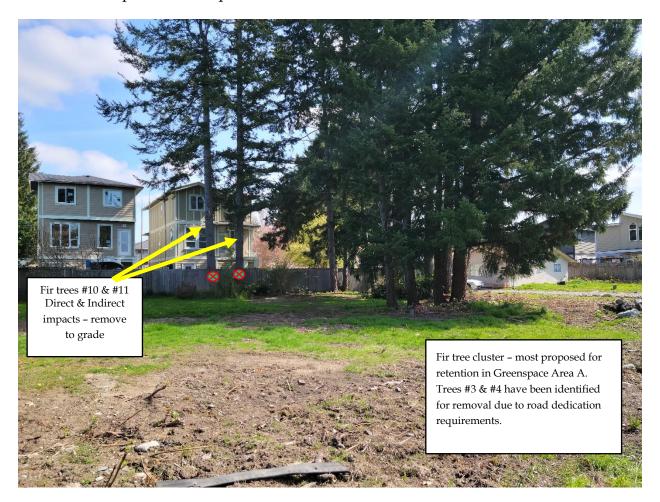
Photo #3 – Proposed Greenspace Area A & Fir trees #10 & #11

This photo identifies several of the trees slated for retention in the Greenspace Area A. The road dedication and alignment will more than likely require two firs to be removed and impact surrounding tree root zones. The Project Arborist shall monitor and assess root impacts during excavation and constructive impacts for this area of the site. Further tree removal recommendation may occur and there for certain trees should be "To Be Determined" (TBD) for retention and/or removal outcomes.

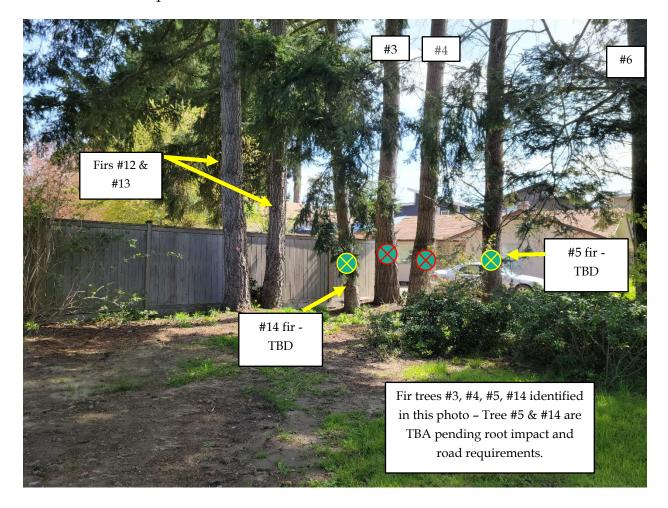
Photo #5 - Greenspace Area A - Fir Trees #3-#5 & #14

- Low to moderate root impacts could occur under the existing proposal for tree identified to be retained within the Greenspace Area "A". Our observations indicate that a portion of trees #5 & #14 could impacted due to their positioning next to the proposed road.

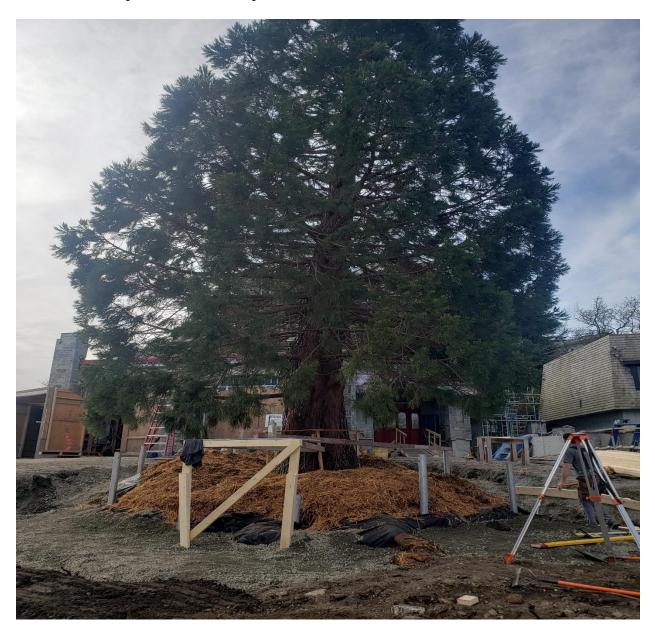
Photo #1 - Example Tree - Giant Sequoia

In this photo you can see a sequoia tree which was preserved through excavation mitigation techniques in March 2021. SouthShore performed the excavation and remediation as the Project Arborist. This tree was given a 50% chance to survive. As of May 2024, the tree is performing "Fair" in the landscape.

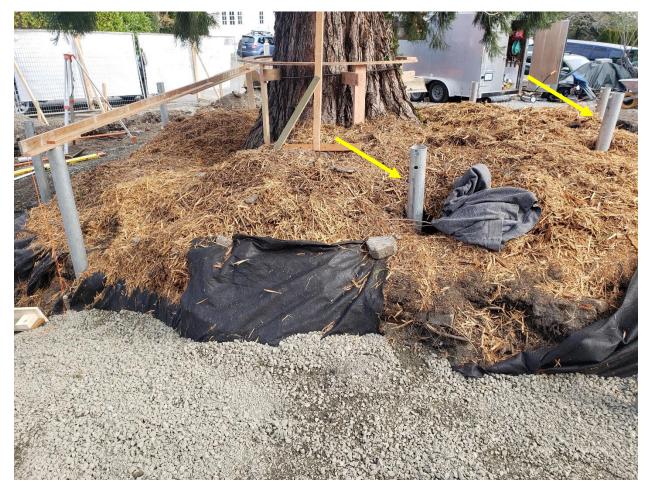
Photo #2 - Example Tree - Giant Sequoia

See how the root edges are wrapped for further protection. Aeration tubes have been placed within the trees CRZ (yellow arrows).
