**2825-2831 KNOTTY PINE ROAD &  
2830 JACKLIN ROAD—LANGFORD, BC**

**CONSTRUCTION IMPACT ASSESSMENT &  
TREE MANAGEMENT PLAN**

DATE OF ISSUANCE: May 30, 2024

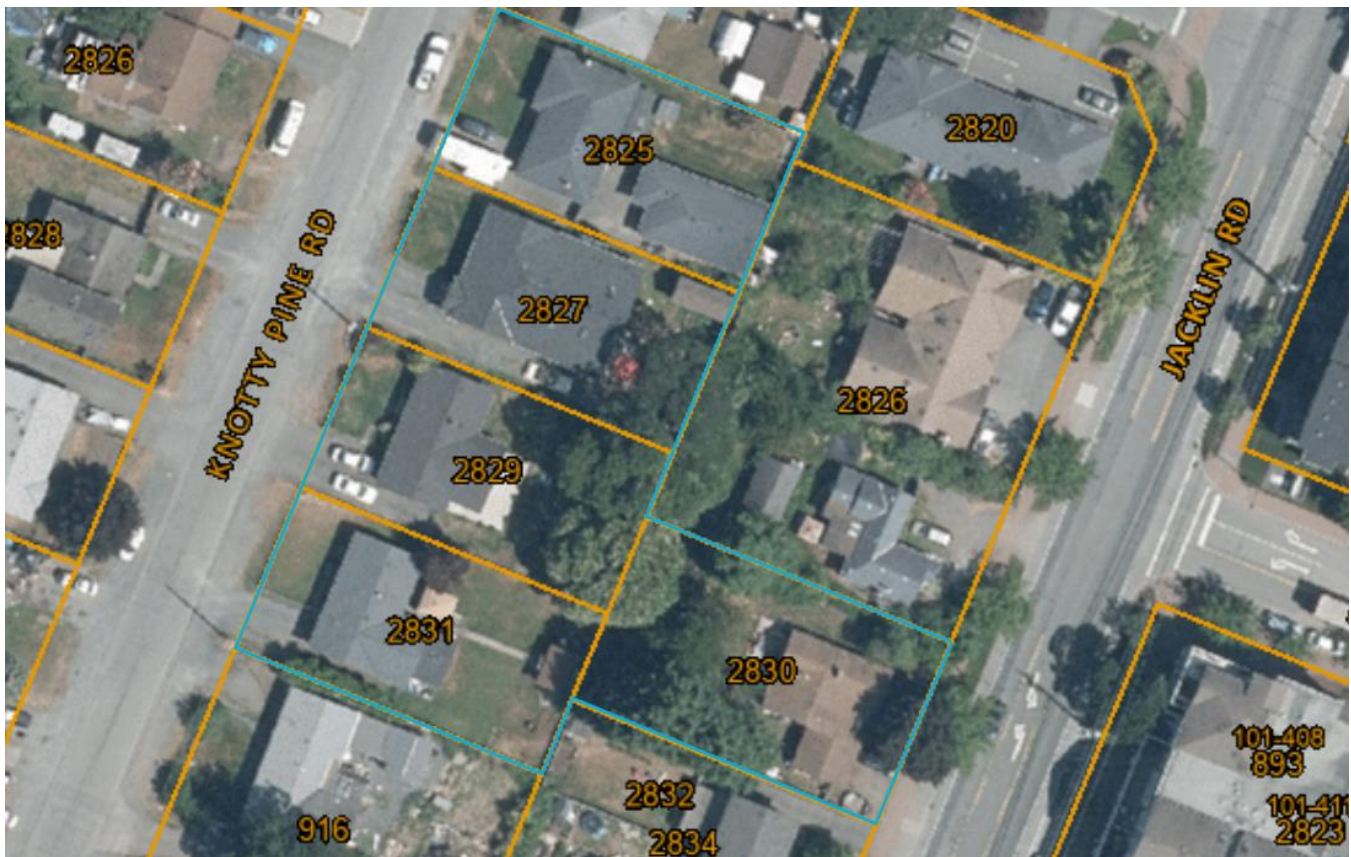
**Figure 1:** Site context air photo: The approximate boundary of the subject site is outlined in blue.

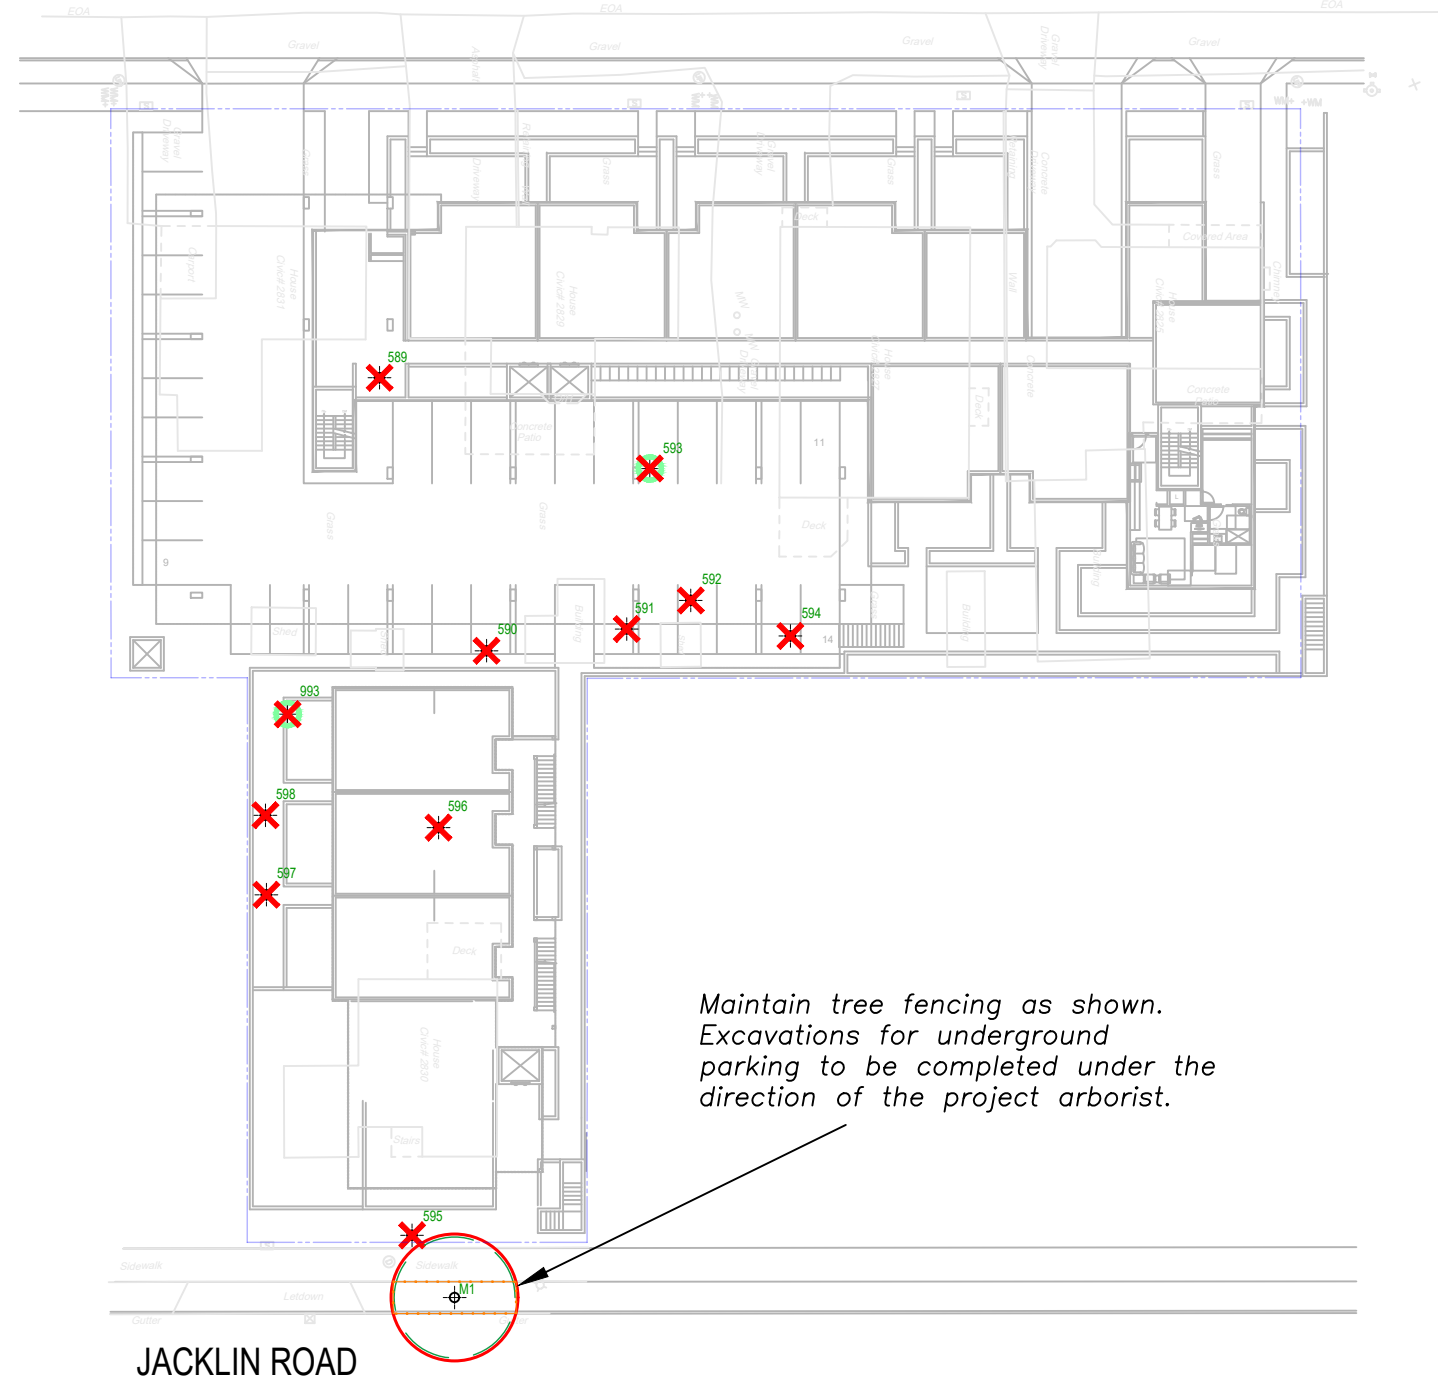
**APPENDIX A - TREE MANAGEMENT PLAN**

The new underground parking facility is proposed within the CRZ of **flowering cherry (*Prunus serrulata* 'Kwanzan')** M1 (~35cm DBH):

- If a cut-slope is prescribed by a geotechnical engineer, over-excavation within the CRZ could result in significant impacts to M1. However, we anticipate excavation will be restricted to the east property line. If this is the case, we anticipate this tree can be retained.
- The project arborist must supervise all excavations within the CRZ and perform any required root pruning.
- Protective barrier fencing is currently installed to the edges of the existing curb and sidewalk (due to development on the adjacent lot). We recommend this fencing is maintained until the completion of the proposed construction on the subject properties.

If **Norway Maple (*Acer platanoides*) #595** (37cm trunk diameter below unions) is approved for removal, care must be taken to minimize damage to the canopy of M1, as the crowns of the two trees are intertwined.

- #589-598, 993

- We recommend all services are connected outside the CRZ and drip line of M1, if possible. Any excavations or clearance pruning required within these areas must be reviewed and/or directly supervised by the project arborist.
