Arborist Report for Meaford Ave - Viking Development, Langford, BC

Date of visit: 19 August, 2024

Brief: Development of Meaford Ave at Station Ave in Langford will impact some of the trees existing on this site. This report covers assessment and recommendations for tree management with respect to the proposed development.

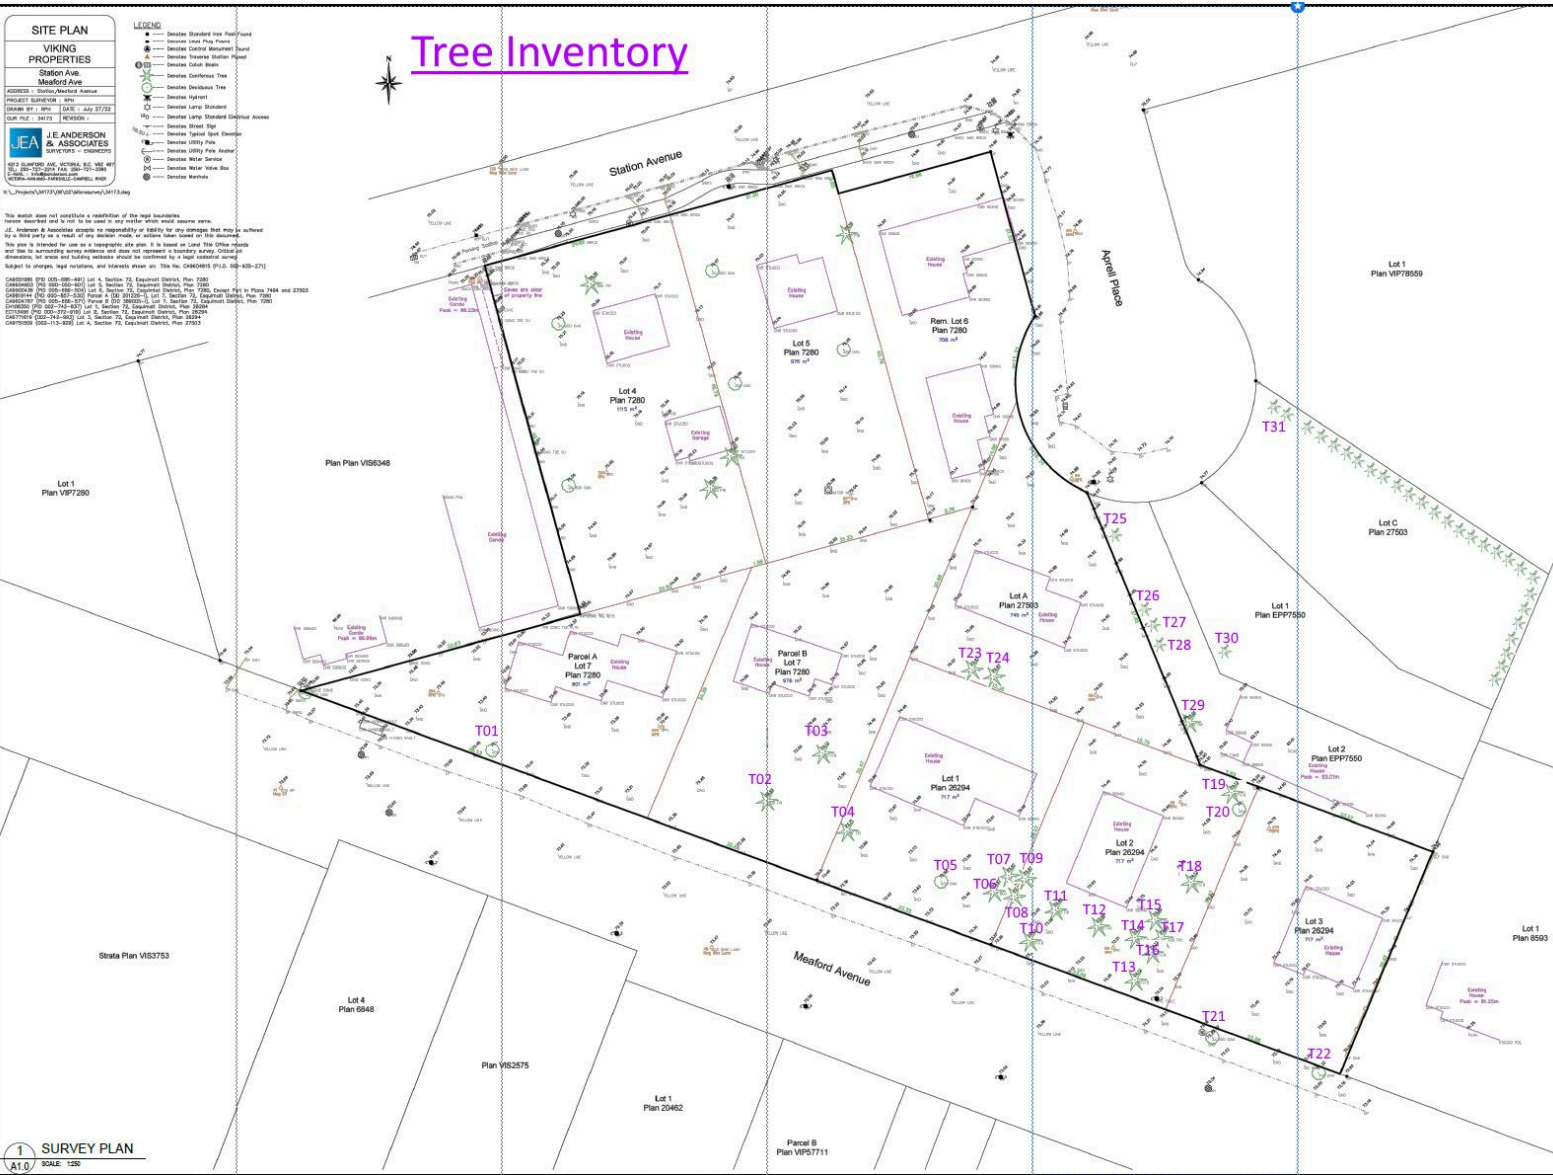
Tree Inventory

#	Tree type	DBH(cm)	Height(m)	TPZ(m)	Condition	Recommendation - Reason
T01	Pacific Dogwood	139	10	3	good	REMOVE - within sidewalk area
T02	Douglas Fir	119	30	6	good	REMOVE - within building envelope
T03	Douglas Fir	39.5	19.2	4	good	REMOVE - within building envelope
T04	Douglas Fir	52	20	4	good	REMOVE - within building envelope
T05	Gary Oak	43	19	5	good	REMOVE - within building envelope
T06	Douglas Fir	85	32	5	good	REMOVE - roots will be compromised
T07	Douglas Fir	42	11	3	good	REMOVE - roots will be compromised
T08	Douglas Fir	80	27	4	good	REMOVE - roots will be compromised
T09	Douglas Fir	78	32	4	good	REMOVE - roots will be compromised
T10	Deodora Cedar	31	13	2	good	REMOVE - within parking area
T11	Douglas Fir	79	26	5	good	REMOVE - within parking area
T12	Douglas Fir	92	26	5	good	REMOVE - within parking area
T13	Leylandii Cypress	33	11	3	good	REMOVE - within driveway entrance

T14	Douglas Fir	65	22	4	good	REMOVE - within parking area
T15	Douglas Fir	58	22	4	good	REMOVE - within parking area
T16	Douglas Fir	45	20	4	good	REMOVE - within parking area
T17	Douglas Fir	54	18	4	good	REMOVE - within parking area
T18	Douglas Fir	98	29	5	good	REMOVE - within parking area
T19	Douglas Fir	23	12	4	good	REMOVE - within parking area
T20	Red Maple	21	11	3	good	REMOVE - within parking area
T21	Gary Oak	98	15	4	good	REMOVE - within sidewalk area
T22	Gary Oak	76	14	4	good	REMOVE - within sidewalk area
T23	Leylandii Cypress	26	11	3	good	REMOVE - within building envelope
T24	Leylandii Cypress	25	11	3	good	REMOVE - within building envelope
T25	Emerald Cedar	46	7	1	fair	REMOVE - replace with more suitable selection
T26	Emerald Cedar	41	7	1	fair	REMOVE - replace with more suitable selection
T27	Emerald Cedar	46	8	1	fair	REMOVE - replace with more suitable selection

T28	Emerald Cedar	33	8	1	fair	REMOVE - replace with more suitable selection
T29	Douglas Fir	66	25	5	good	REMOVE - within parking area
T30	Emerald Cedar	78	8	1	good	REMOVE - replace with more suitable selection
T31	Leylandii Cypress Hedge	42m long hedge	7	1	good	RETAIN
