Arborist Report

2795 and 2799 Scafe Road,

April 23, 2024

Newform Construction Ltd.

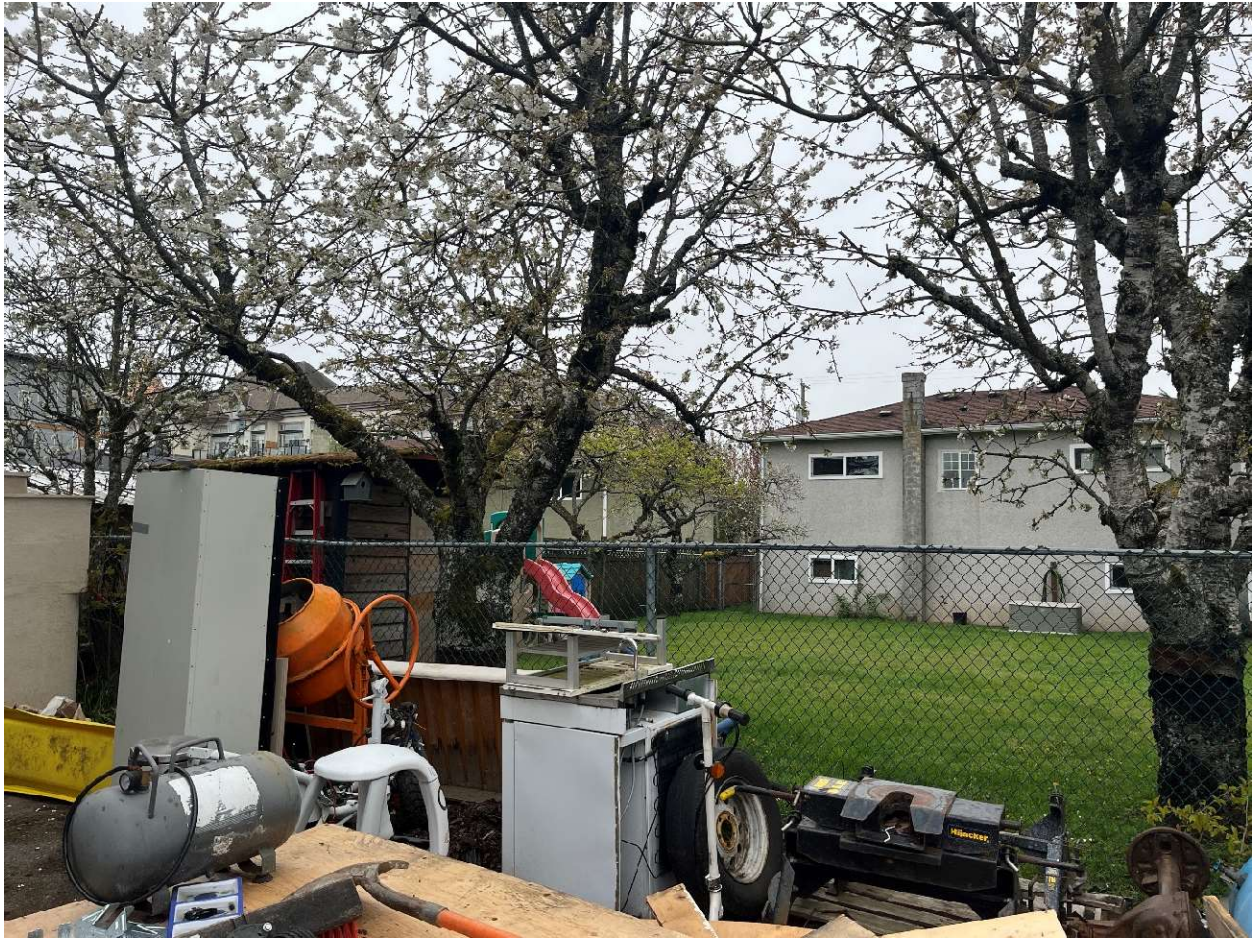
Capital Tree Service Inc.								
Appendix A - Tree Inventory/Hazard Ratings Summary								
Location: 2795 and 2799 Scafe Road, Langford, BC V9B 3W6								
Date: April 11, 2024					Conditions: 8°C, overcast, 5km/hr south gusting to 10km/hr			
Tag #	Species	DBH (cm)	PRZ (m)	Canopy (r) (m)	Health/Structure	Bylaw Protected	Action	Observations
OS1a	Cherry	30	4	4	F/F	Yes	Retain	Estimated DBH. 4x stem 2m above grade. ~0.5m from fenceline. Pruned for driveway clearance. Poor aspect ratio in union. Wrap with Tanglefoot application.
OS1b	Cherry	35	4	4	F/F	Yes	Retain	Estimated DBH. 4x stem 2m above grade. ~0.5m from fenceline. Pruned for driveway clearance. Poor aspect ratio in union. Wrap with Tanglefoot application.
OS1c	Cherry	15	2	4	F/F	No	Retain	Estimated DBH. 4x stem 2m above grade. ~0.5m from fenceline. Pruned for driveway clearance. Poor aspect ratio in union. Wrap with Tanglefoot application.
OS1d	Cherry	15	2	4	F/F	No	Retain	Estimated DBH. 4x stem 2m above grade. ~0.5m from fenceline. Pruned for driveway clearance. Poor aspect ratio in union. Wrap with Tanglefoot application.

OS2a	Cherry	40	5	4	F/F-P	Yes	Retain	Estimated DBH. 2x stem ~1.2m above grade. Central stem previously removed, poor cut leading to fungal infection. Narrow angle of attachment. Poor aspect ratio in union. Included bark.
OS2b	Cherry	35	4	4	F/F-P	Yes	Retain	Estimated DBH. 2x stem ~1.2m above grade. Central stem previously removed, poor cut leading to fungal infection. Narrow angle of attachment. Poor aspect ratio in union. Included bark.
OS3a	Apple	10	1	1	F/F-P	No	Retain	Estimated DBH. 2x stem ~1.1m above grade. Poor aspect ratio in union. Condensed canopy. Epicormics.
OS3b	Apple	10	1	1	F/F-P	No	Retain	Estimated DBH. 2x stem ~1.1m above grade. Poor aspect ratio in union. Condensed canopy. Epicormics.
423	Plum	52	6	6	G/F	Yes	Remove	Embedded metal. Tree house. 3x stem ~2m above grade. Poor aspect ratio in union. Limbs previously reduced leading to large epicormics.
OS4	Douglas fir	20	2	3	G/F-P	Yes	Remove	Stem deflections. Growing directly adjacent to fenceline.

Figure 4. OS1-3. From left to right along fence are trees OS3 (in back along left side of photo), OS2 (center), and OS3 (right side).

Five (5) trees are proposed for retention and protection. Trees OS1 (a-d), OS2 (a-b), and OS3 (a-b) are located at 2765 Strathmore Road and are located ~1m from the existing fence line. Depending on the roots encountered during excavation, tree health could be significantly compromised. CTS recommends that these trees be retained and reassessed at the time of excavation. Tree removal should be predicated on the roots encountered and pruned during excavation.

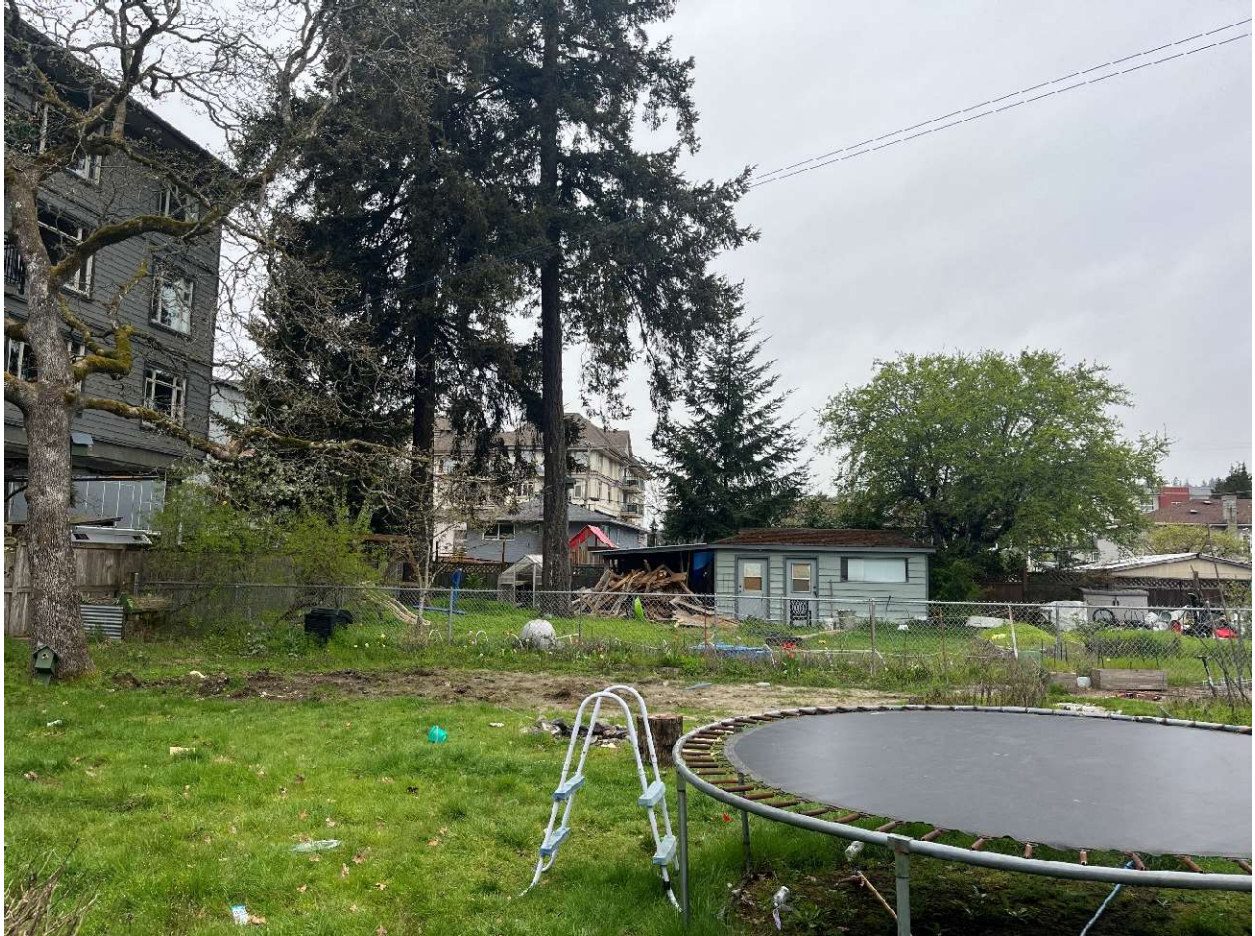
Five (5) trees are proposed for removal due to building impacts. Trees 420 (a Garry oak) and 422 (a Douglas fir) are located within the footprint of the proposed building. The proposed development will require an edge-to-edge excavation which means that trees 421 (a Douglas fir) and 423 (a Plum) will be within over excavation. OS4, a 20cm Douglas fir located 2769 Strathmore Road, is located directly adjacent to the existing fence line and would likely be destabilized by an edge-to-edge excavation. As excavation would extend to within 1.5x the trunk diameter, significant tree destabilization can be expected¹. OS4 is therefore recommended for removal.

422	Douglas fir	82	10	5	F-P/P	Yes	Remove	Previously topped. Chlortic canopy. Resinosis. Slightly swollen basal stem. Dieback. Relatively new development within PRZ.
421	Douglas fir	93	11	5	F/P	Yes	Remove	Previously topped. Relatively new development within PRZ. Dieback. Deadwood.
420	Garry oak	59	7	8	F/F-P	Yes	Remove	Dieback. 10cm deadwood. Relatively new development within PRZ. Uneven canopy. Embedded hardware.

Figure 5. Backyards. From left to right are trees 420 (Garry oak), 421 (Douglas fir), 422 (Douglas fir), OS4 (juvenile Douglas fir), and 423 (Plum).
