TALMACK
URBAN FORESTRY
— Consultants Limited —

3084-3094 Jacklin Rd, Langford, BC

Tree Protection Plan & Tree Management Plan

DATE OF ISSUANCE: May 8, 2025

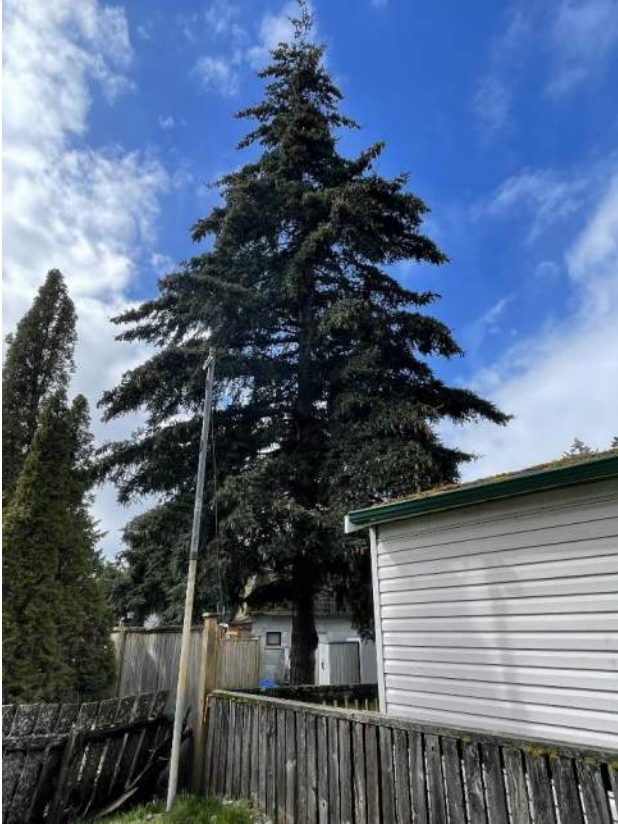
Photograph 1: OS1 beyond Western property line.

The following private offsite trees (indicated by ID #) are located where they may be possible for retention provided their critical root zones are adequately protected during construction. The project arborist must be onsite to supervise any excavation required within the critical root zone of this tree(shown on the tree management plan in *Appendix A*).

Underground Parking excavation: The excavation for the portions of the underground parking that encroaches into the critical root zones of trees to be retained must be supervised by the project arborist. This will be particularly important when excavating next to tree number OS1 if it is going to be successfully retained. No excavation can occur beyond the limits of property line. To minimize the extent of the excavation into the critical root zones, it may be necessary to use shoring techniques such as sheet piling, shotcrete or similar methods to reduce the requirements for cut slope and over excavation. Any roots critical to the tree's survival must be retained and any non-critical roots in direct conflict with the excavation must be pruned to sound tissue to encourage new root growth.

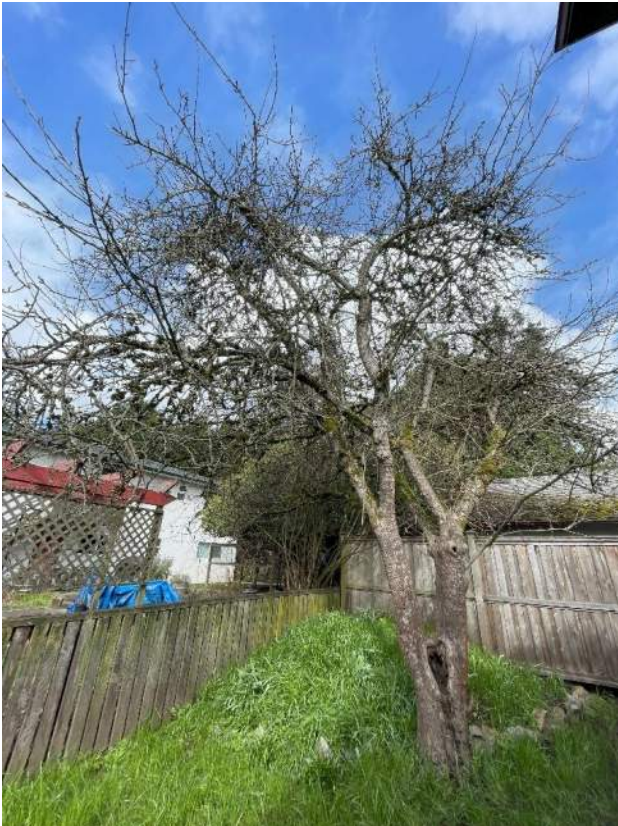
Photograph 2: Tree 3645 in Northwest corner of project site.

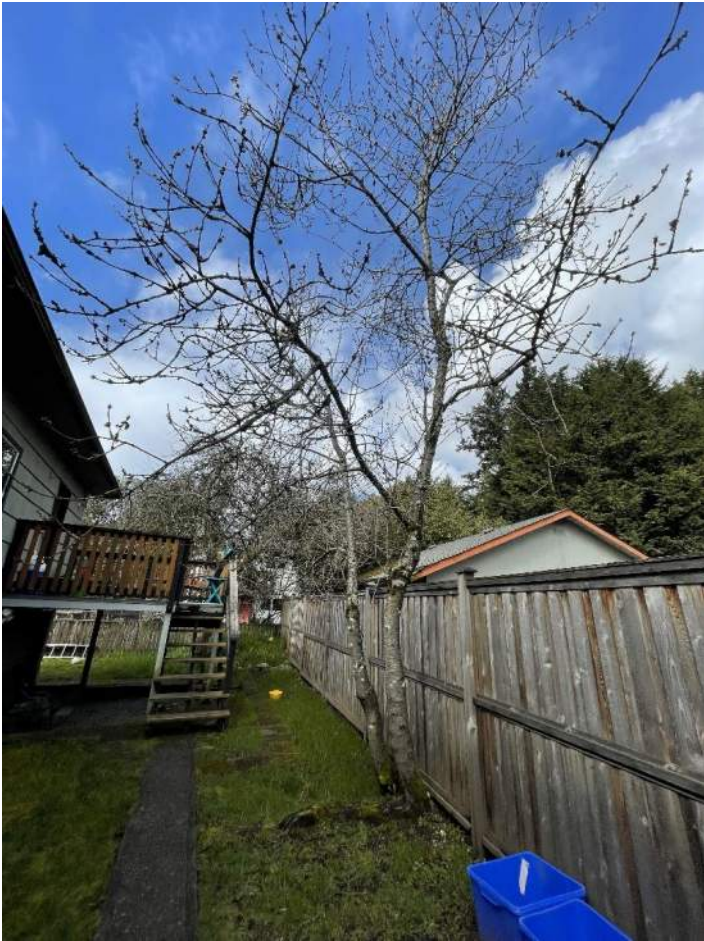
Photograph 3: tree 3646 along Northern property boundary.
