Arborist Report

646 Atkins Avenue

Langford, BC

Revised July 19, 2024

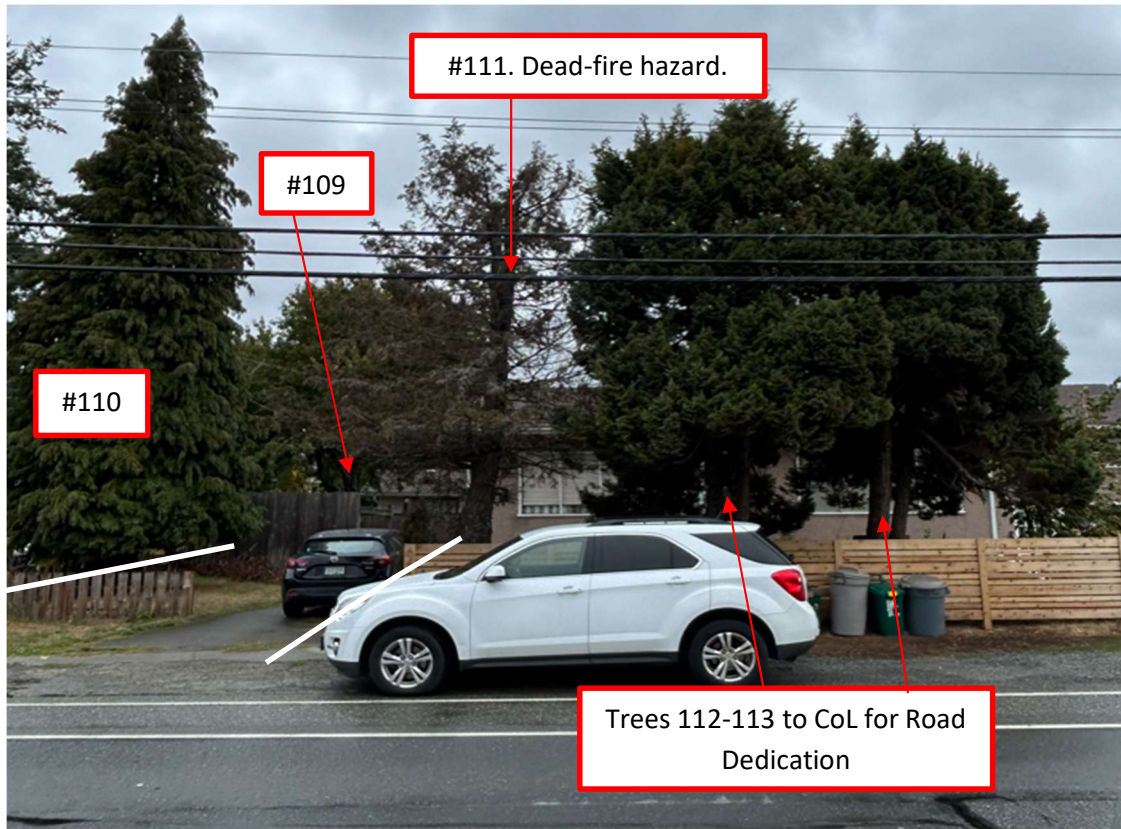
**Figure #3- Site Photo-** Atkins Ave frontage. White line indicates proposed driveway.

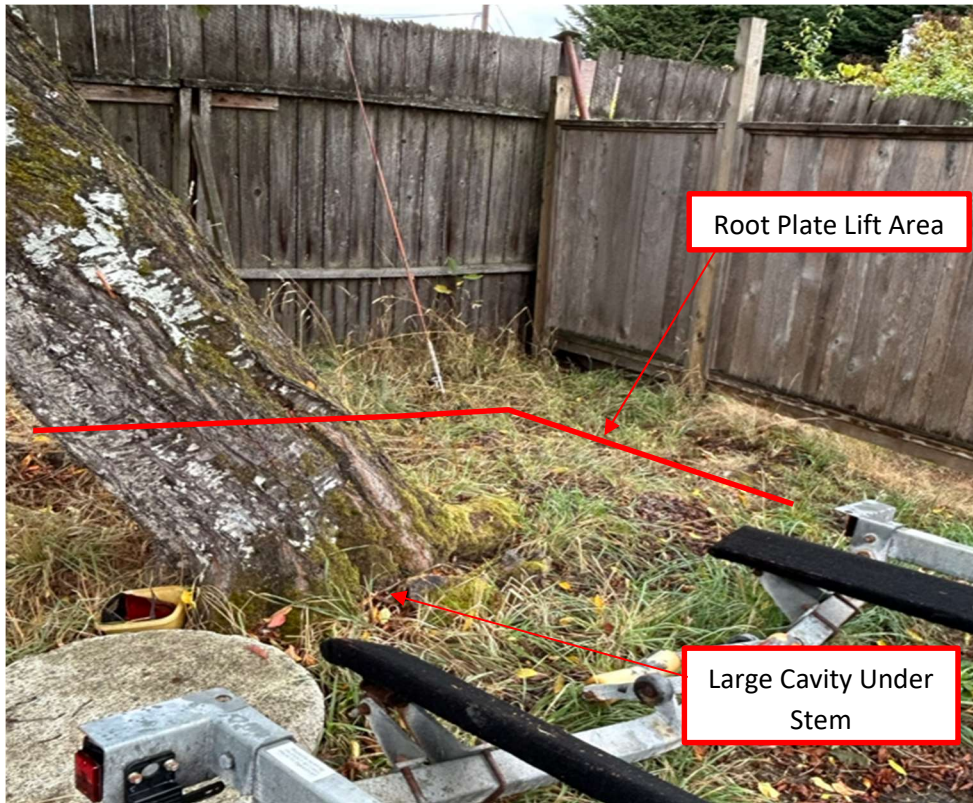
**Figure #5- Site Photo- Tree #109 poor rooting structure. Showing root plate lift and cavity. Dangerous-Remove.**

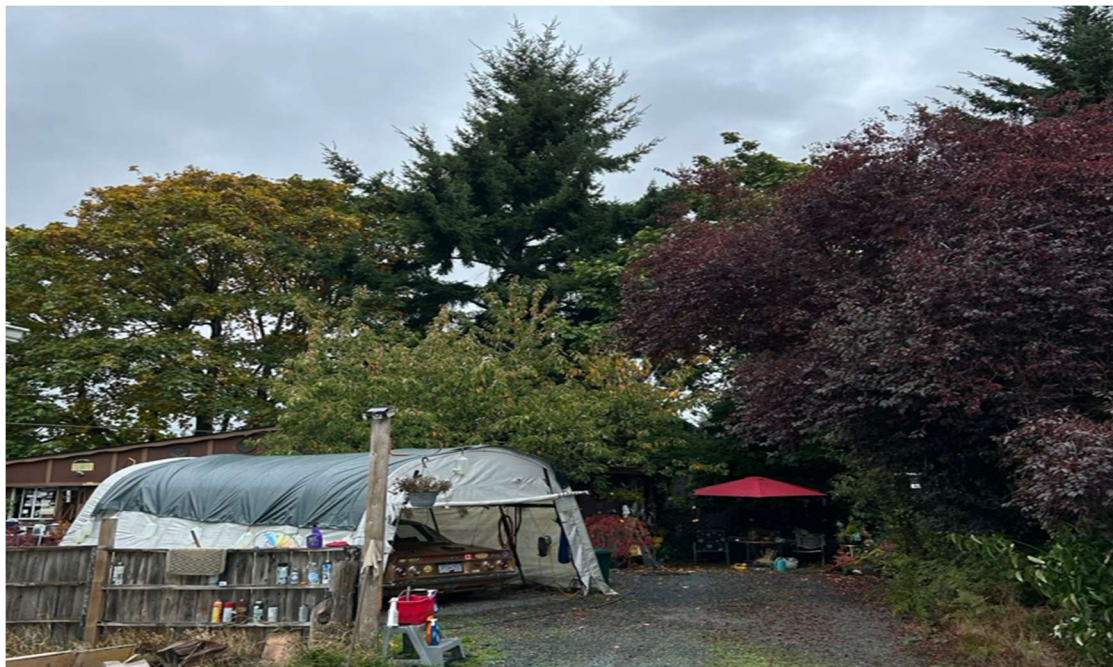
**Figure #6- Site Photo-** North facing to back of lot showing trees #101-105.

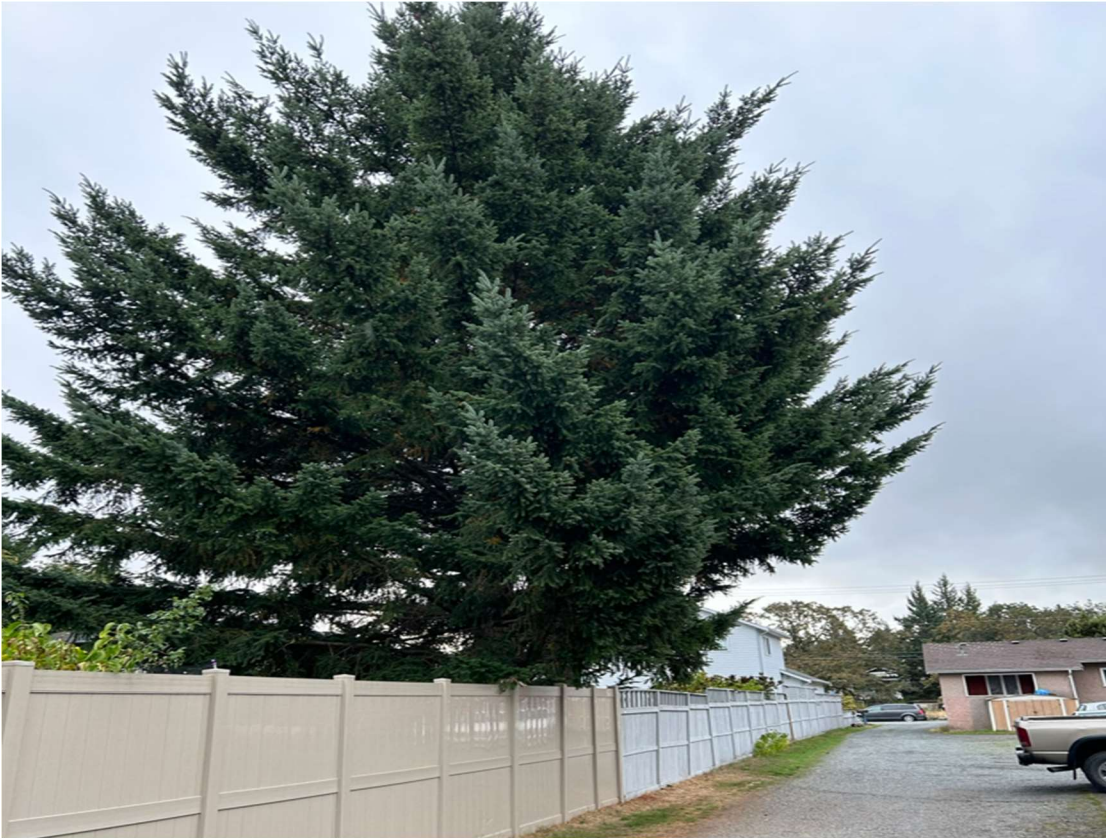
113	Juniper	22		FP/FP	Yes	Retain		Multi stem .5m AG. Included bark.	Proposed road dedication to City of Langford.
114	Douglas Fir	est 60		FP/F	Yes	Retain		Private tree Protect and Retain. 1m from property line. 10cm dead wood.	Low impact.
115	Douglas Fir	est 70		FP/F	Yes	Retain		Private tree Protect and Retain. 1m from property line. 10cm dead wood. Multi top with narrow angles of attachment.	Low impact.

**Figure #7 Site Photo-** SE facing. Private trees #114 & 115.
