**950 BRAY AVENUE &  
2866-2870 RITA ROAD—LANGFORD, BC**

**CONSTRUCTION IMPACT ASSESSMENT &  
TREE MANAGEMENT PLAN**

DATE OF ISSUANCE: May 7, 2024

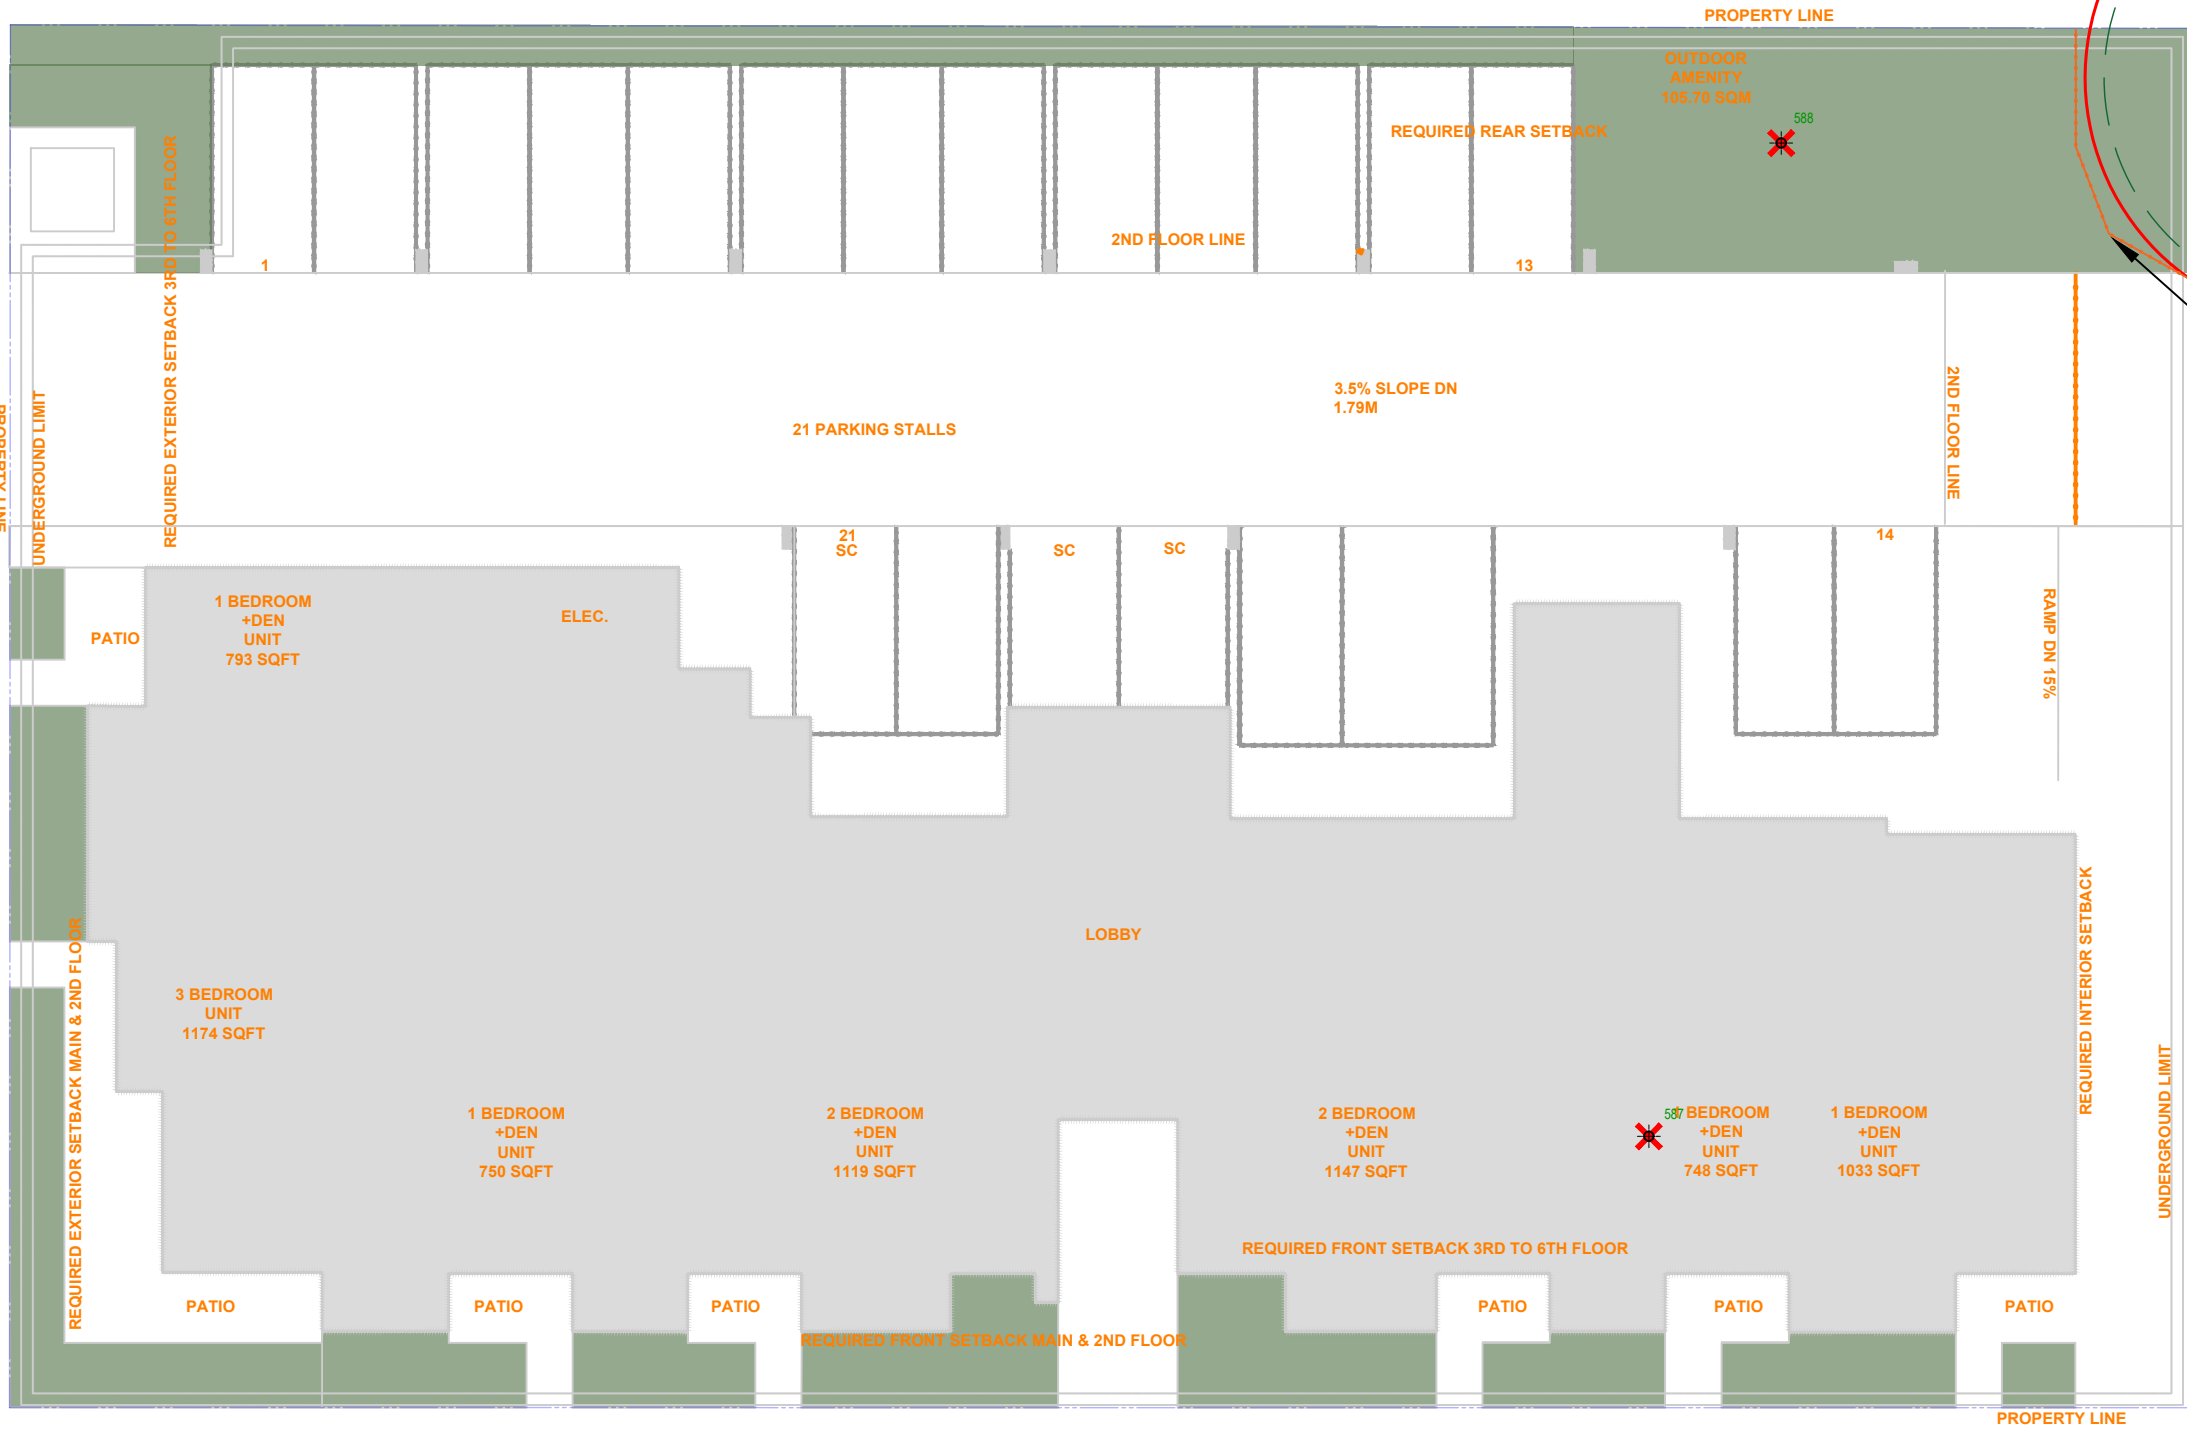
**APPENDIX A - TREE MANAGEMENT PLAN**

The new underground parking facility is proposed within the CRZ of **Garry oak (*Quercus garryana*) OS1** (~47/30cm DBH):

- If a cut-slope is prescribed by a geotechnical engineer, over-excavation within the CRZ could result in significant impacts to OS1.
- If retention is desired by the tree owner(s), a shoring plan must be developed to restrict over-excavation to (preferably) 0.5m beyond the north property line.

- The project arborist must supervise all excavations within the CRZ and determine the final retention status based on the size and quantity of roots encountered (that require pruning). If excavations can be limited to 0.5m from the north property line, we anticipate the tree can be viable for long-term retention.

- Protective barrier fencing should be installed at the demolition phase and maintained at the edge of the CRZ until commencement of underground parking excavations, at which point the fencing may be relocated to the edge of the cut line (provided the project arborist is contacted). Permission must be granted by the tree owners to install barrier fencing on their property.

If retention is desired, install tree fencing as shown. Adjust at time of underground parking excavations – under the direction of the project
