**950 BRAY AVENUE &  
2866-2870 RITA ROAD—LANGFORD, BC**

**CONSTRUCTION IMPACT ASSESSMENT &  
TREE MANAGEMENT PLAN**

DATE OF ISSUANCE: May 7, 2024

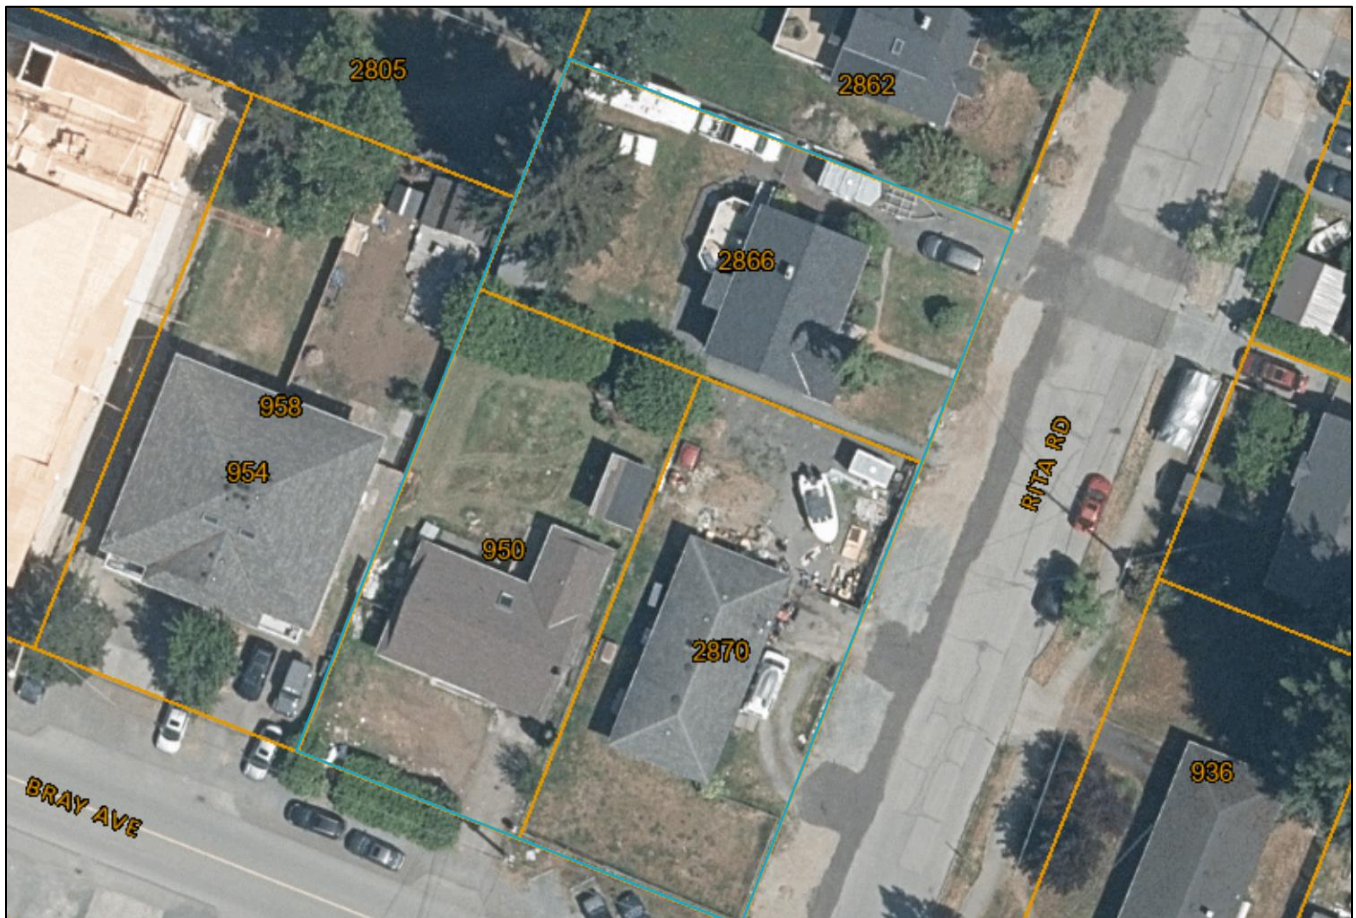
The on and off-site tree resource consists primarily of native species growing in open landscape conditions (see **Figure 1**):

**Figure 1:** Site context air photo: The approximate boundary of the subject site is outlined in blue.
